# **J. ARONSTEIN**

## **REDUCING THE FIRE HAZARD**

## **IN ALUMINUM-WIRED HOMES**

**Latest update: May 21, 2007**

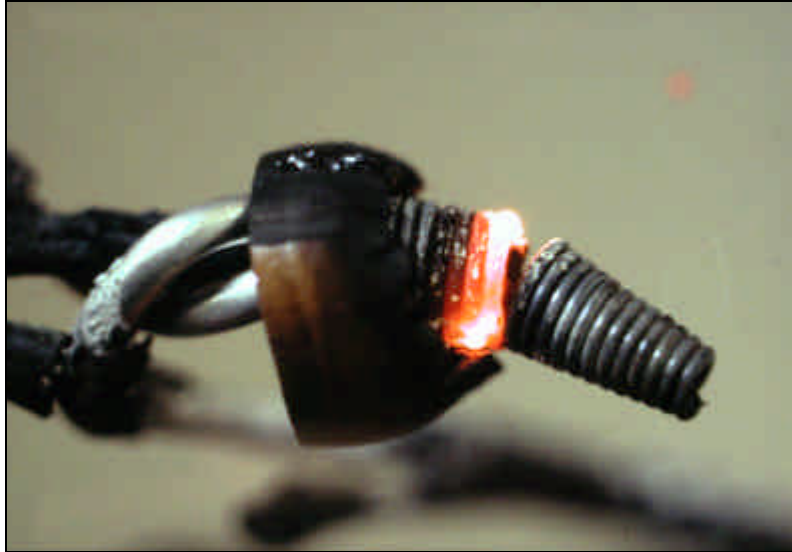
The most certain corrective action for all cases would be to rewire the home with copper wire. This is expensive and impractical in most cases. A practical approximation to rewiring can be achieved by a method known as "pigtailling", using a specially-selected connector and installation method to splice a short length of solid copper wire to each aluminum wire end. The copper wire "pigtail" is then connected to the circuit breaker, light fixture, receptacle, dishwasher, or other termination. This method is only effective if the connections between the aluminum wires and the copper pigtails are extremely reliable. Pigtailling with some types of connectors, even though they might be presently listed by UL or certified by CSA for the application, can lead to increasing the hazard.[5][6] (See Figure 1.)

FIGURE 1 - ALUMINUM WIRE SPLICES MADE WITH TWIST-ON CONNECTORS CAN BE DANGEROUS. The use of most types of twist-on connectors with aluminum wire can lead to hazardous results. This twist-on pigtail connection (two #10 aluminum wires with one #12 copper wire, in a 20-amp circuit), made with a twist-on connector that was UL listed for use with aluminum wire at the time, remains electrically functional in the circuit, but it becomes extremely hot whenever a significant amount of current flows. The heat has deteriorated the insulation on both the connector and the wires. In this photo, a portion of the connector's spring is red hot, at current well below the circuit rating.

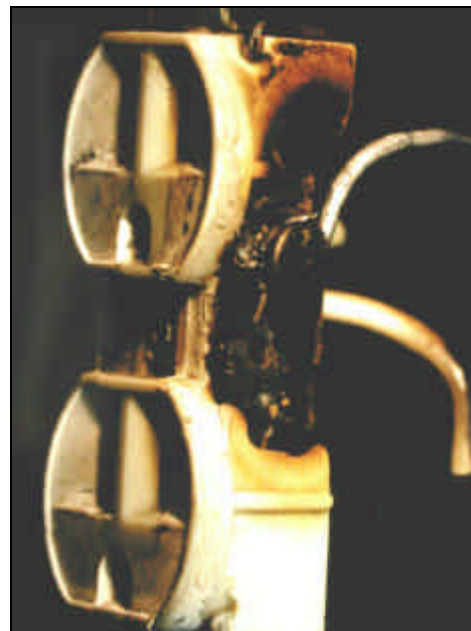
FIGURE 2 - EXAMPLE OF OVERHEATING OF ALUMINUM-WIRED TERMINALS ON A RECEPTACLE. Enough heat was generated by current flowing through the aluminum wire connections to cause charring of the receptacle body and disintegration of the insulation that was on the wire. Note that the face of the receptacle, as the homeowner or an inspector would have seen it, with the cover plate on, would look normal.

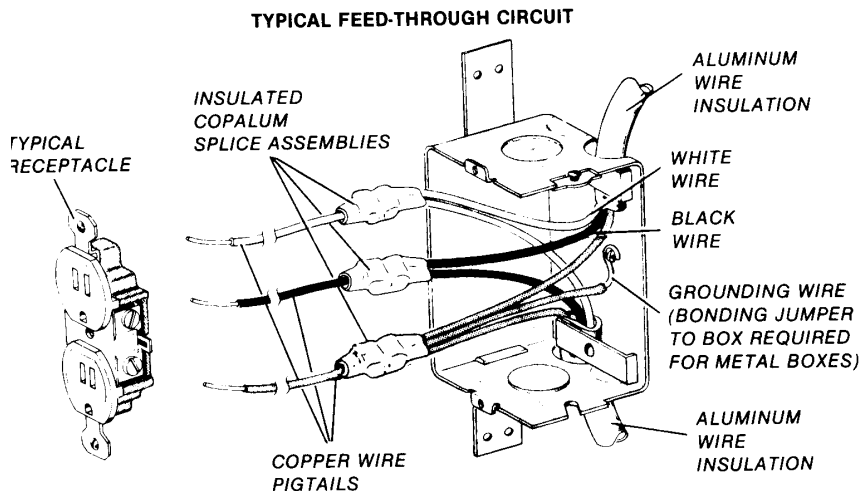
**FIGURE 3 - Illustration of copper wire pigtailed to aluminum circuit wires using AMP\* (Tyco) COPALUM connectors  
(Source: U.S. Consumer Product Safety Commission)**

The AMP\* "COPALUM" connector is applied using a special set of dies in a power-driven tool. After application of the connector, a heat-shrink insulator is applied. Solid copper wire "pigtailed" spliced to the aluminum wire this way may be connected to receptacles, switches, circuit breakers, lamps, appliances, and all other terminations in the normal manner. (Note: all aluminum branch circuit wire terminations in the home must be treated this way for a complete and permanent repair, as the overheating problem involves all types of aluminum-wired connections.)

Repair by pigtailing, using COPALUM connectors installed by a qualified electrician, is the only method considered by the U.S. consumer Product Safety Commission ("CPSC") to be a permanent repair. Their recommendation is based on extensive testing. The method is described in more detail, and sources for more information are provided in an article in Consumer Reports, January 1981.[7] While the application of COPALUM connectors is considered to be satisfactory without special preparation of the aluminum conductor, it is suggested that antioxidant compound and abrasion as per Section 1A (above) be used to provide an additional safety factor.

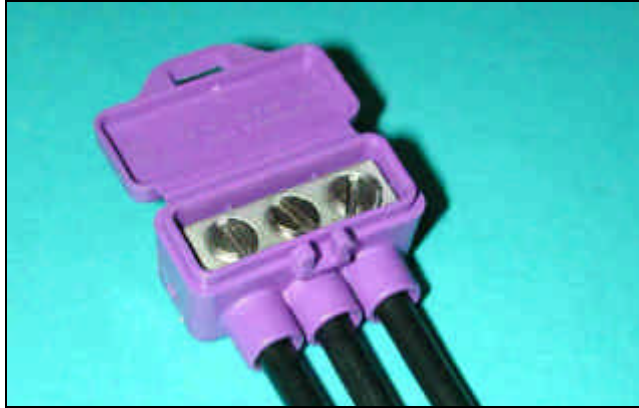
FIGURE 4 - King Innovation "AlumiConn" Connector

On the basis of the test results, the AlumiConn connector is predicted to have a high probability of failure-free long-term safe performance, PROVIDED THAT THE SETSCREWS ARE CAREFULLY TIGHTENED TO THE MANUFACTURER'S RECOMMENDATION (see notes below). If not tightened to the manufacturer's recommendation, there is a possibility that the connections will degrade due to wire stresses and/or motion when the completed connection is manipulated into the outlet (or junction) box.

1. The manufacturer's instructions provide two alternative methods for tightening. Either (instruction card, item #3 or 3A) may be used.
2. It is difficult to properly tighten the setscrews if the connector is hand-held. The connector needs to be held in a tool while tightening. The manufacturer has indicated that some electricians are using "channel-lock" type pliers for this purpose. A special holding tool may be developed and made available by the connector manufacturer.

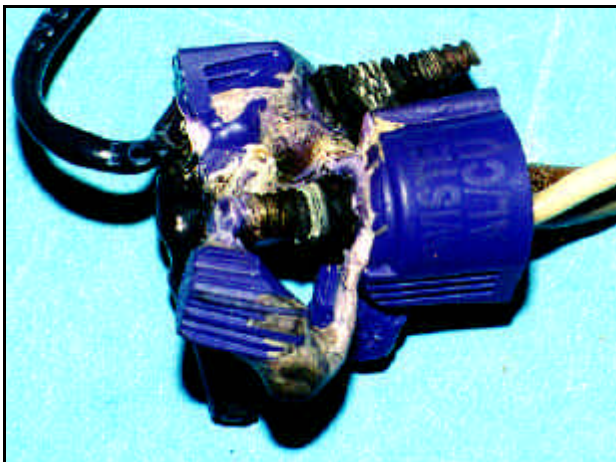
**FIGURE 5 - FIELD FAILURES OF ALUMINUM TO COPPER SPLICES MADE WITH IDEAL #65 CONNECTORS [12]**

A. THESE TWO FAILED SPLICES ARE ADHERED TOGETHER BY THE MELTED PLASTIC SHELLS

3. IDEAL #65: came on the market in the mid-1990's. Within three years of its introduction, the first report of field failure surfaced. There have been additional failures reported since then.

Additionally, field burnouts have now been reported with the Ideal #65 connectors in their rated applications. With CPSC skeptical (and requesting that UL withdraw its listing), the manufacturer initially agreeing that the connector is not for the pigtail retrofit application, independent tests clearly demonstrating poor performance, and field failures reported, the use of the Ideal #65 "Twister" connector for the pigtail application is definitely not recommended. If the COPALUM repair is not available, use the AlumiConn connector (See Section 1C).

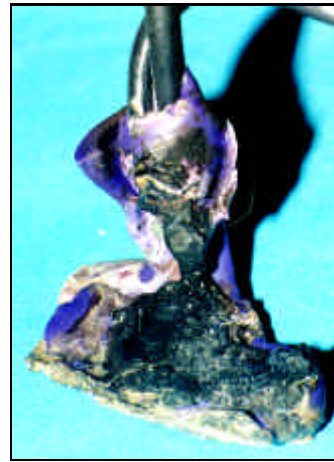
B. SEVERE FAILURE, PLASTIC SHELL MELTED AND CHARRED. THE CHARRING INDICATES THAT IT HAD PROBABLY IGNITED.
